Third Five-Year Review Report for

**Sangamo Weston, Inc./Twelvemile
Creek/Lake Hartwell PCB
Contamination Superfund Site
(Operable Units 1 and 2)**

Pickens County, SC

September 2014

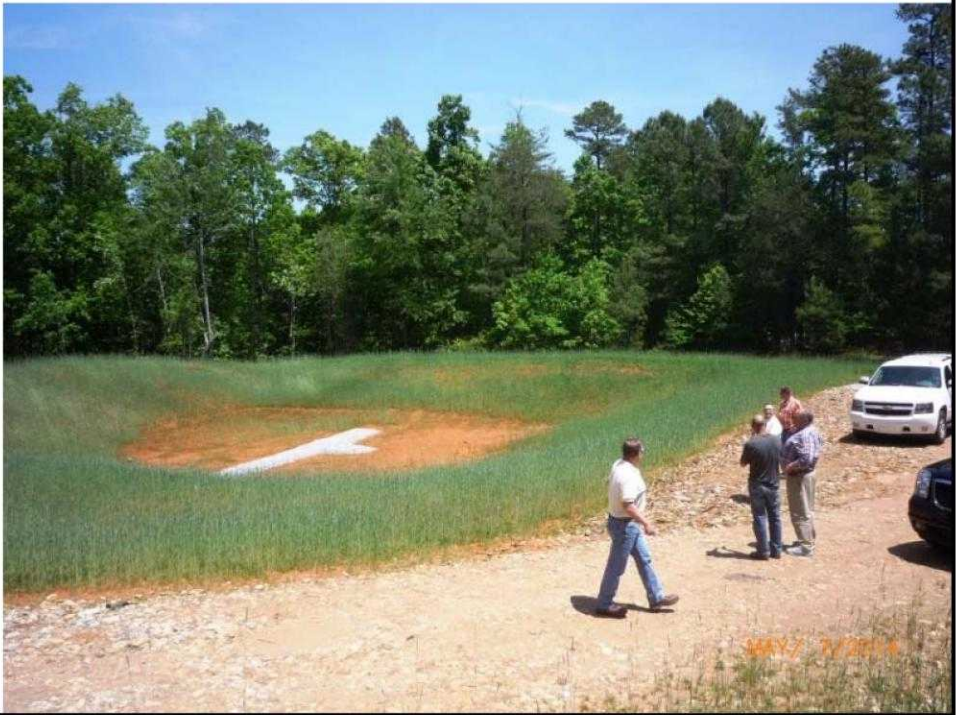
Client Name: Schlumberger Technology Corporation		Site Location: Operable Unit One (OU1)	
Photo No. 9	Date 5-7-2014

Description <i>Plant Site</i> Area H – Post Excavation and Infiltration Gallery			
Photo No. 10	Date 5-7-2014

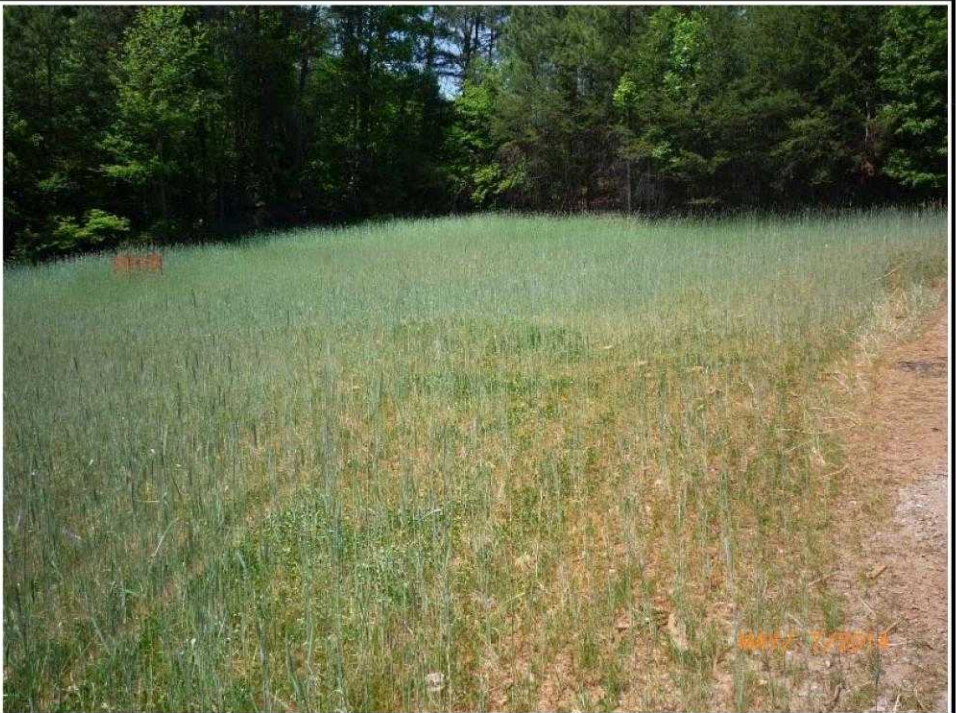
Description <i>Plant Site</i> Area B – Post Excavation, Looking North

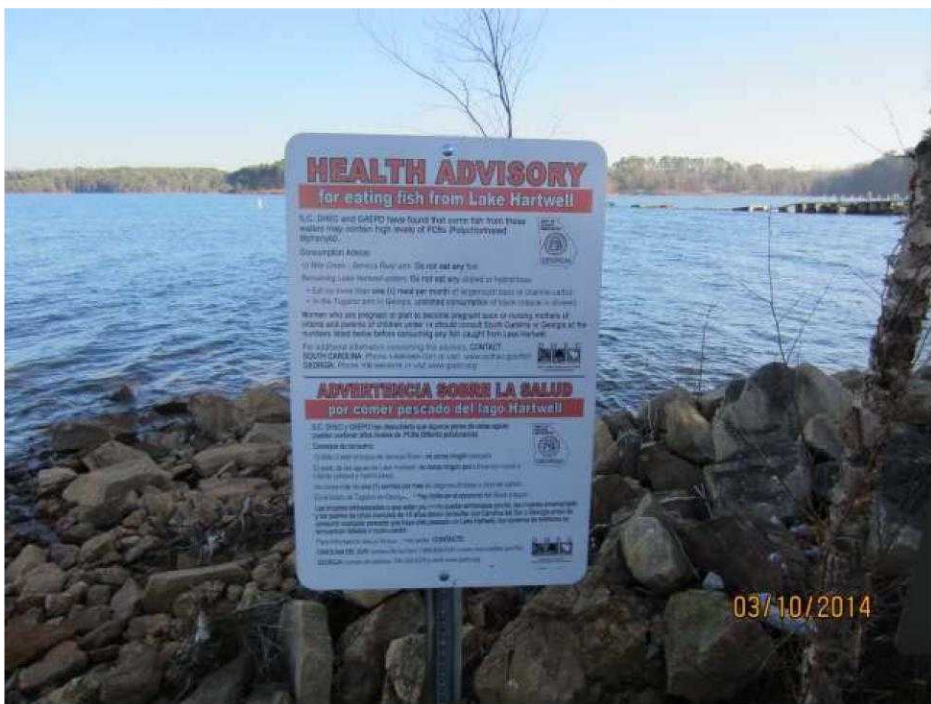
Client Name: Sangamo Weston		Site Location: Lake Hartwell, South Carolina/Georgia	Project No.: 208503.0000.0000
Photo No. 1	Date 03/10/14

Description COE 77 Big Water (Former COE 78); sign in good condition.

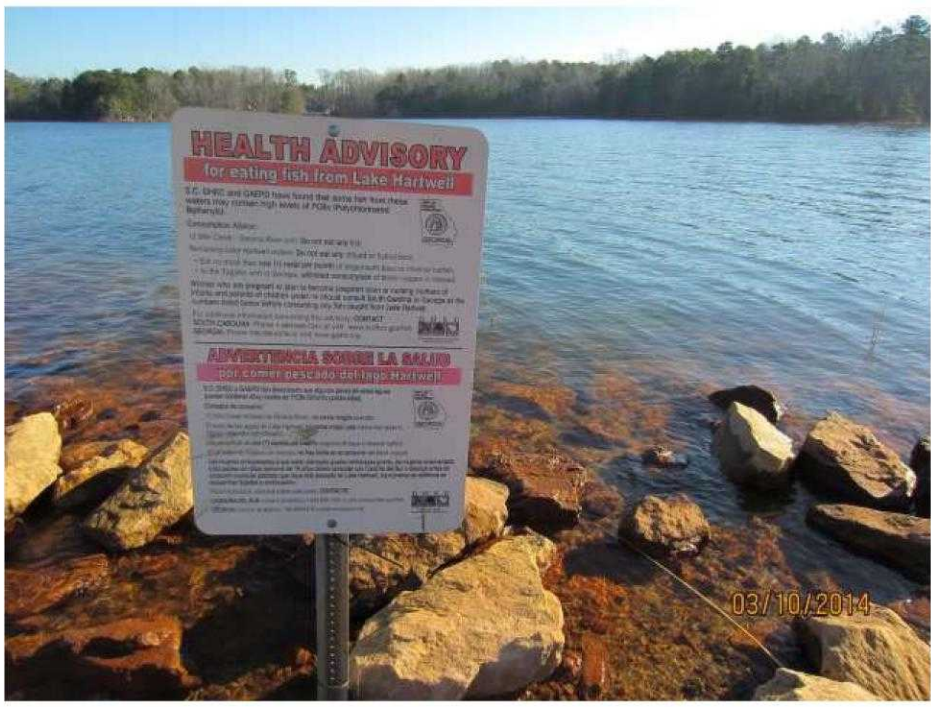
Photo No. 2	Date 03/10/14

Description COE 2 Singing Pines (Former COE 2); sign in good condition. Slightly faded.

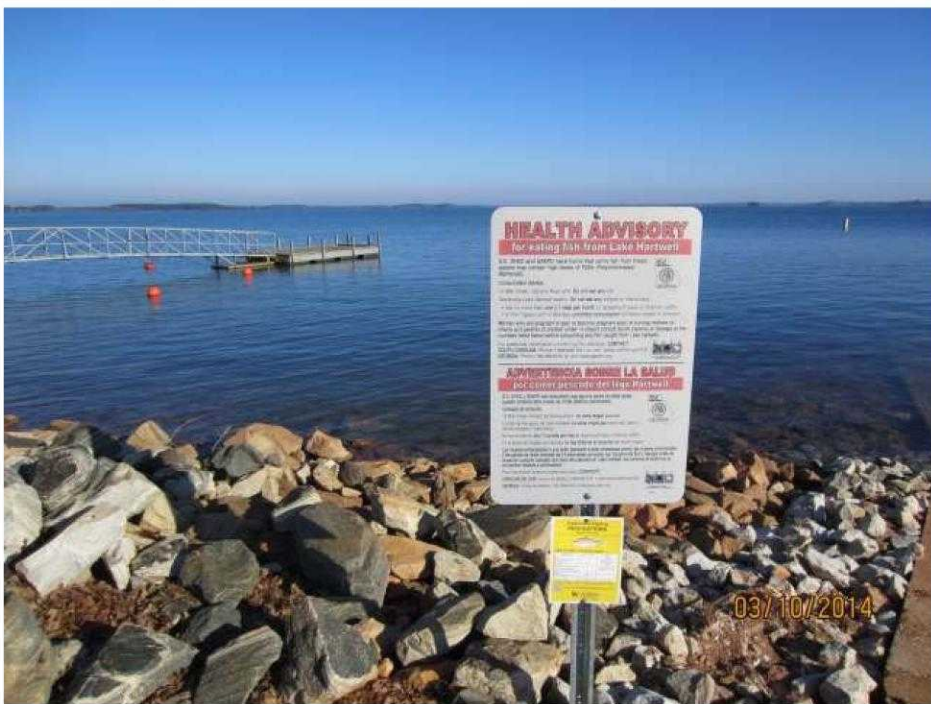
Client Name: Sangamo Weston		Site Location: Lake Hartwell, South Carolina/Georgia	Project No.: 208503.0000.0000
Photo No. 3	Date 03/10/14

Description COE 41 Big Oaks (Former COE 44); sign in good condition.

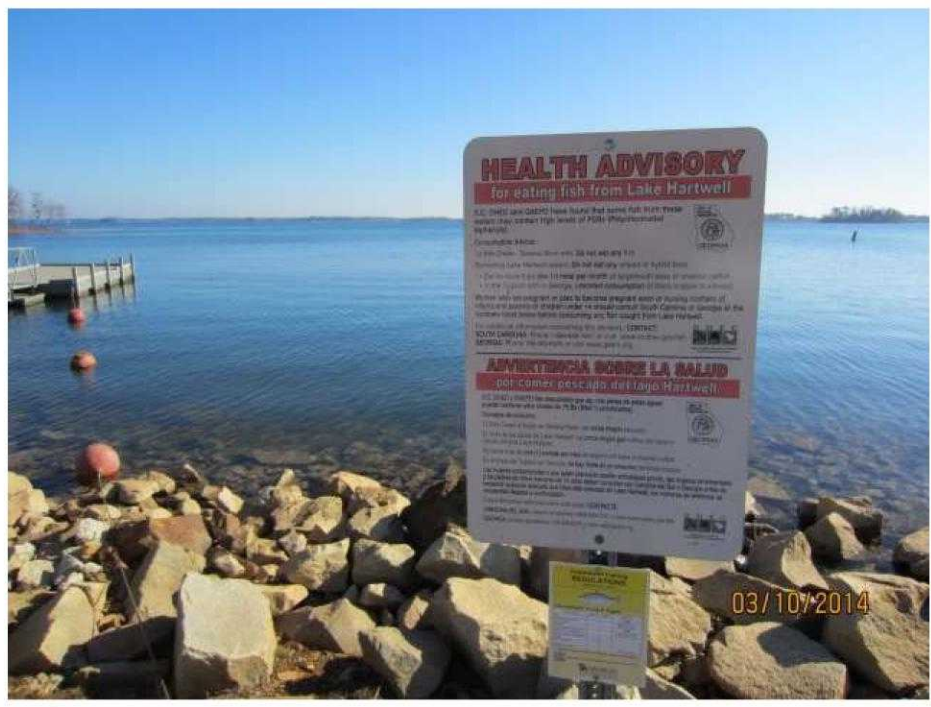
Photo No. 4	Date 03/10/14

Description COE 49 Watsadler (Former COE 52); sign in good condition. Sign has a few dings and is slightly faded.

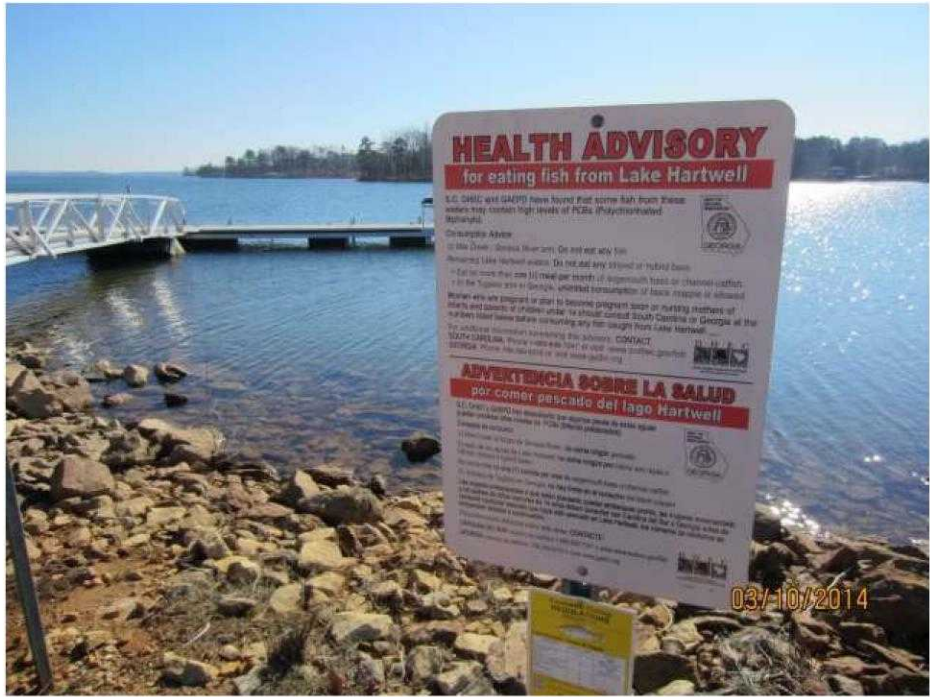
Client Name: Sangamo Weston		Site Location: Lake Hartwell, South Carolina/Georgia	Project No.: 208503.0000.0000
Photo No. 7	Date 03/10/14

Description COE 76 Gum Branch (Former COE 38); sign in good condition. Needs to be relocated – beside old closed ramp; 3 new ramps have been built.

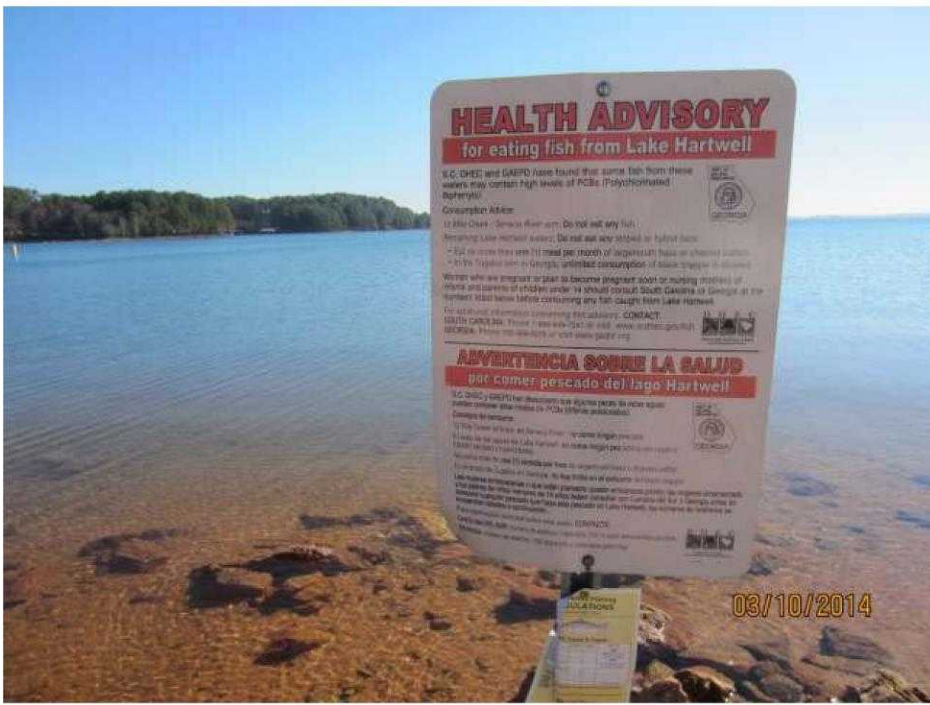
Photo No. 8	Date 03/10/14

Description COE 38 Duncan Branch (Former COE 40); sign slightly damaged and loose on post, need to replace.

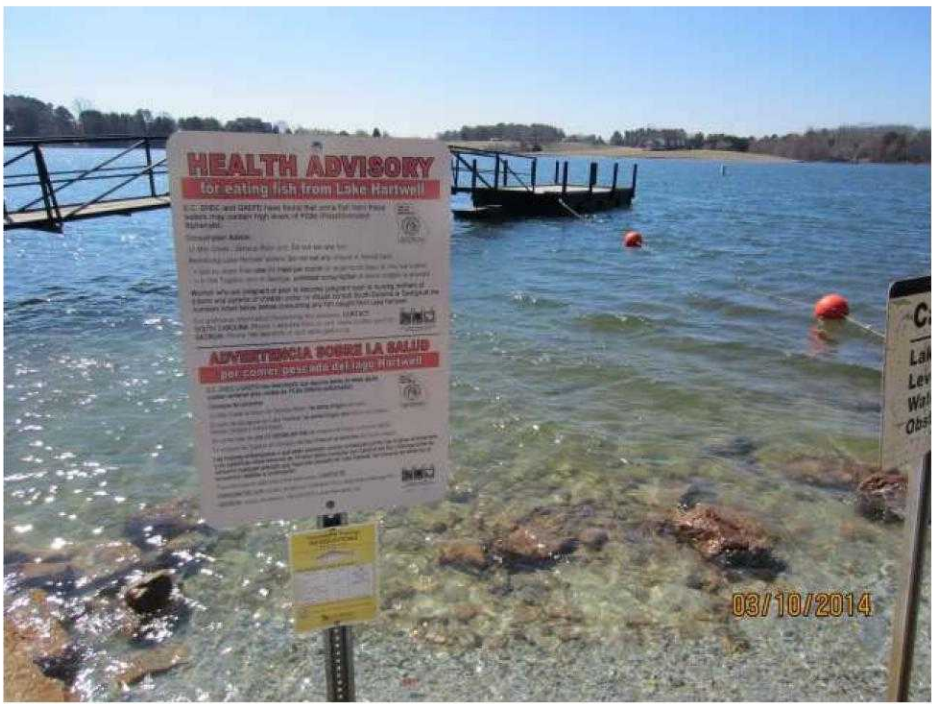
Client Name:		Site Location:	Project No.:
Sangamo Weston		Lake Hartwell, South Carolina/Georgia	208503.0000.0000
Photo No.	Date		
11	03/10/14		
Description COE 35 New Prospect (Former COE 36); sign in good condition.

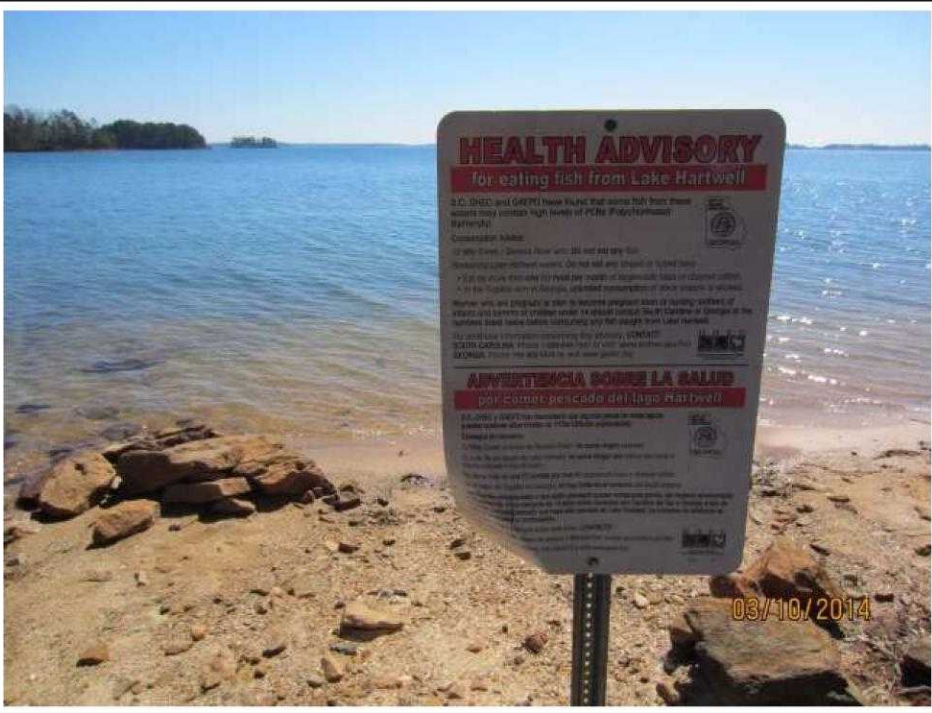
Photo No.	Date		
12	03/10/14		
Description COE 34 Carter's Ferry (Former COE 35); sign damaged. Need to replace.

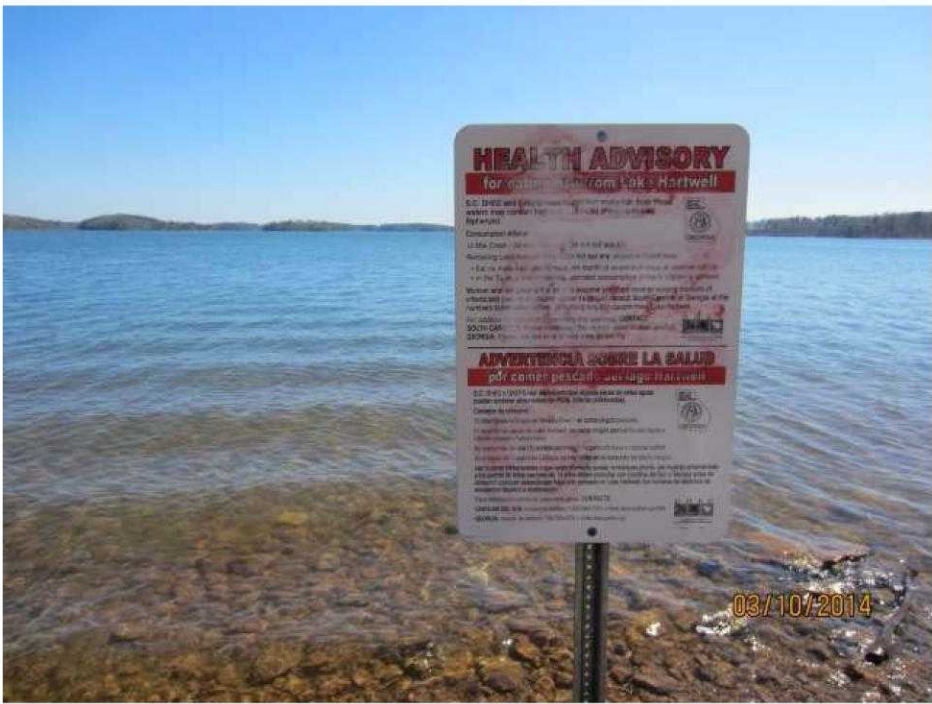
Client Name:		Site Location:	Project No.:
Sangamo Weston		Lake Hartwell, South Carolina/Georgia	208503.0000.0000
Photo No.	Date		
13	03/10/14		
Description COE 33 Crawford's Ferry (Former COE 34); sign defaced. Need to replace.

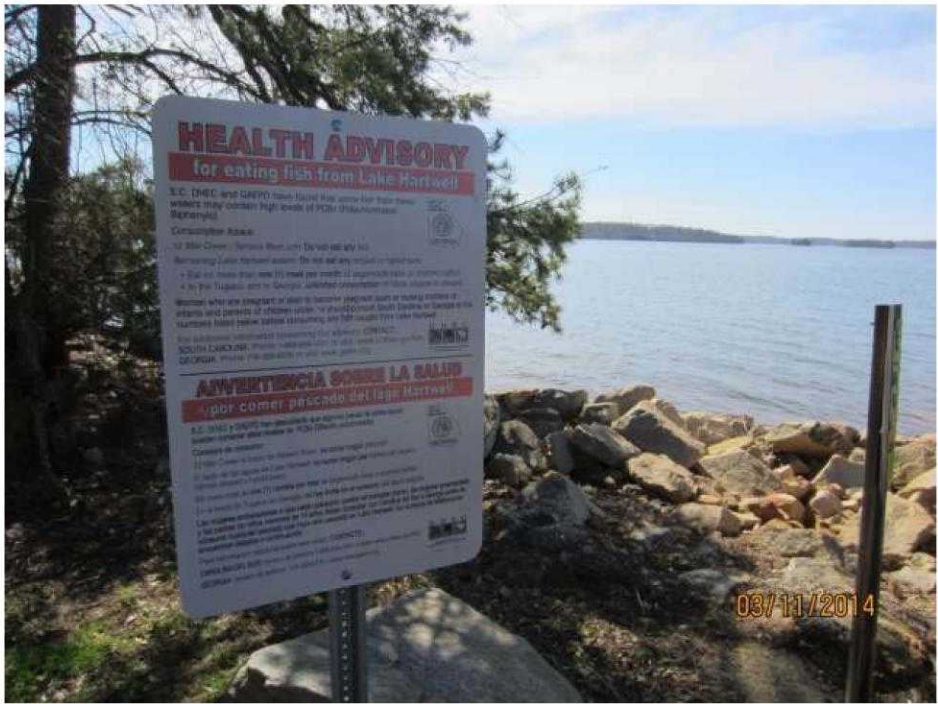
29	03/11/14		
Description COE 19 Weldon Island/Hatton's Ford (Former COE 20); some minor damage.			
Photo No.	Date

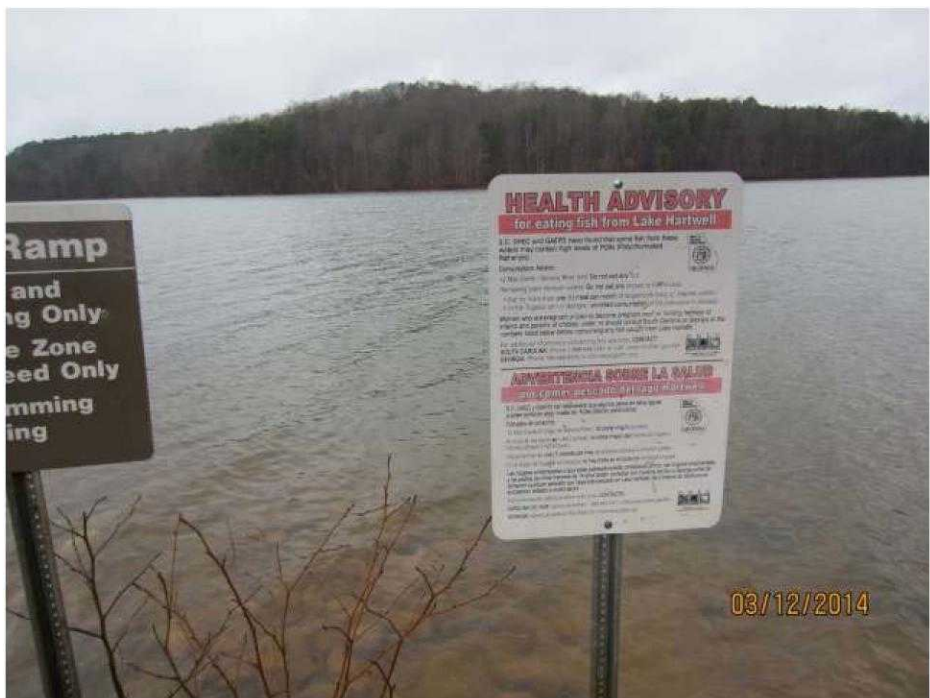
Client Name: Sangamo Weston		Site Location: Lake Hartwell, South Carolina/Georgia	Project No.: 208503.0000.0000
Photo No. 43	Date 03/12/14

Description COE 67 South Union (Former COE 69); sign faded, slight damage.			
Photo No. 44	Date 03/12/14	 	
Description COE 23 Choestoea (Former COE 24); sign in good condition.

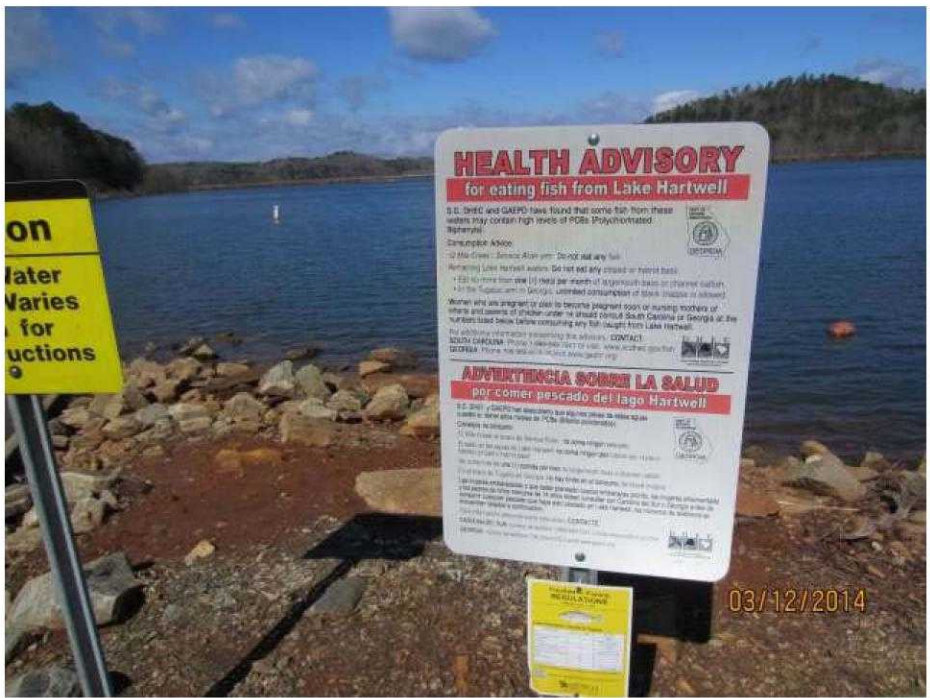
47	03/12/14		
Description COE 27 Stephens County (Former COE 28); sign has some rock damage.			
Photo No.	Date

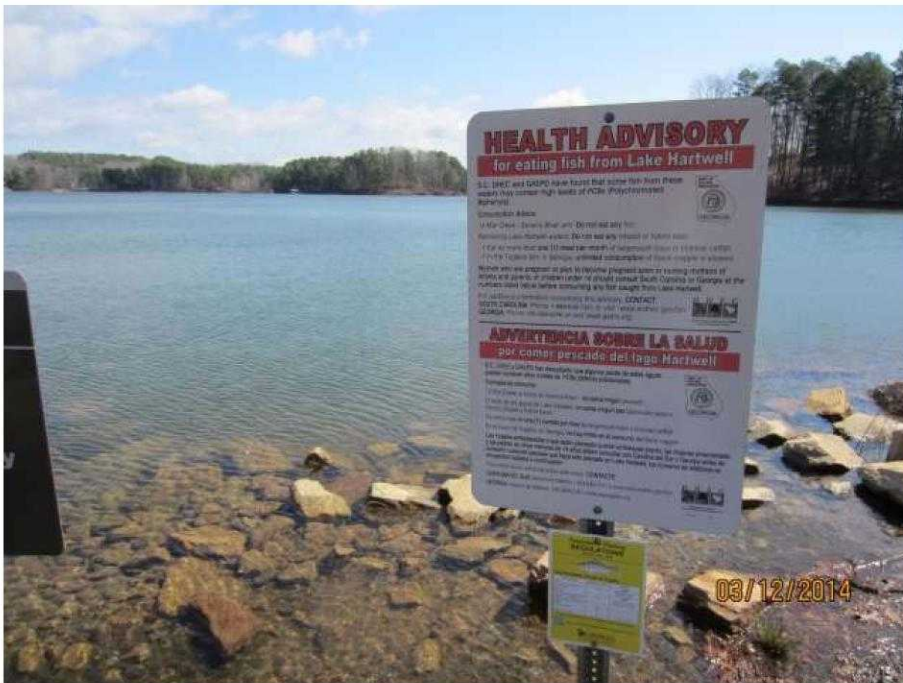
Photo No.	Date		
50	03/12/14		
Description COE 68 Bruce Creek (Former COE 70). Bullet hole in sign.

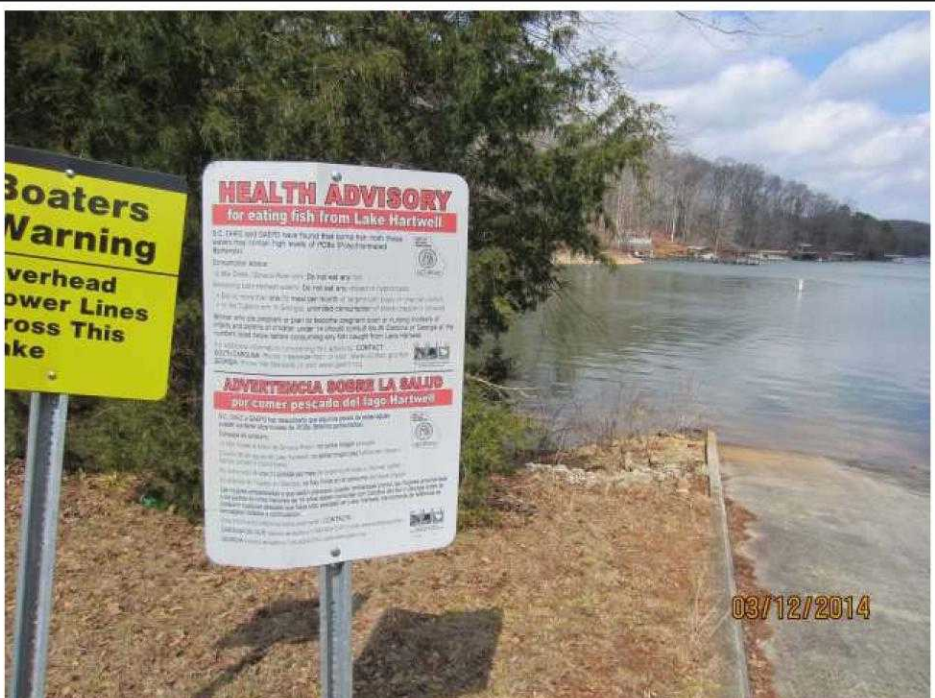
54	03/12/14		
Description COE 71 Franklin County (Former COE 73); sign bent up.
